Durability of cycle-pedestrian
glulam footbridges.
From monitoring to Design for durability.

Enrico Pez

DURABILITY OF CYCLE-PEDESTRIAN GLULAM FOOTBRIDGES

FROM MONITORING TO DESIGN FOR DURABILITY

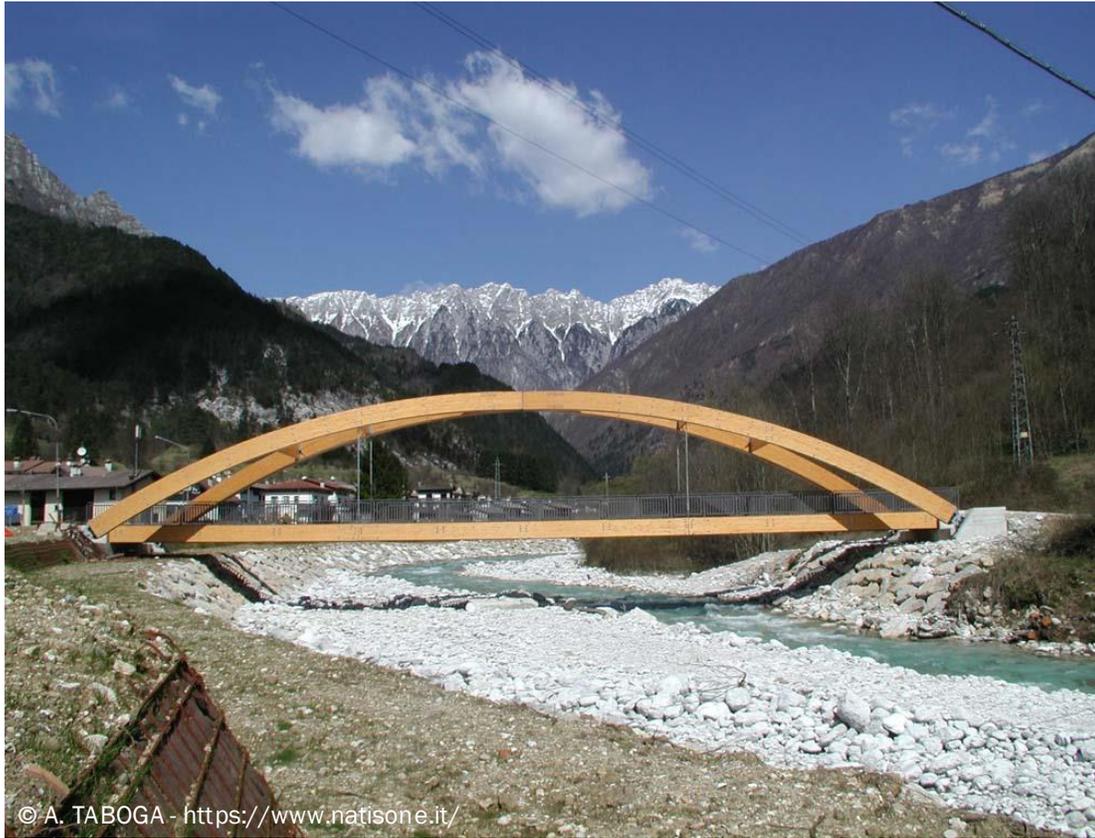
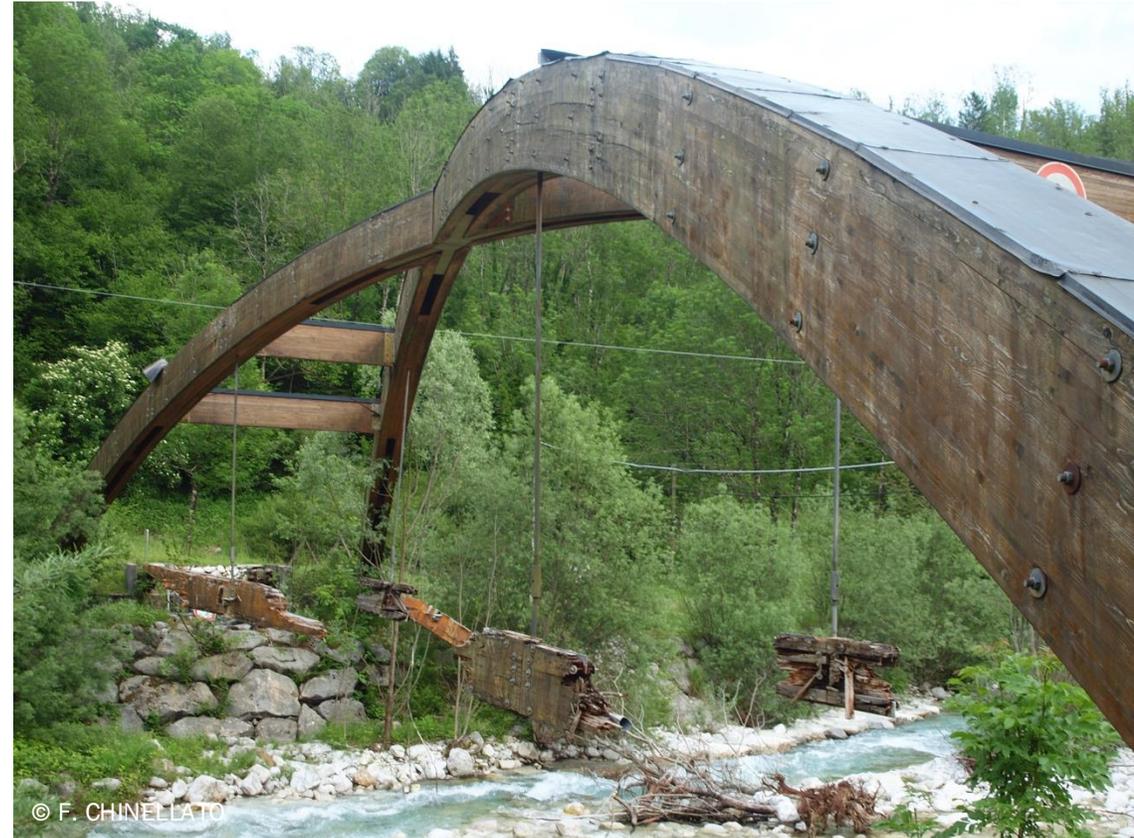
- ▷ Approximately 15 years of effective service (subsequently closed as a precautionary measure)
- ▷ Finally completely demolished

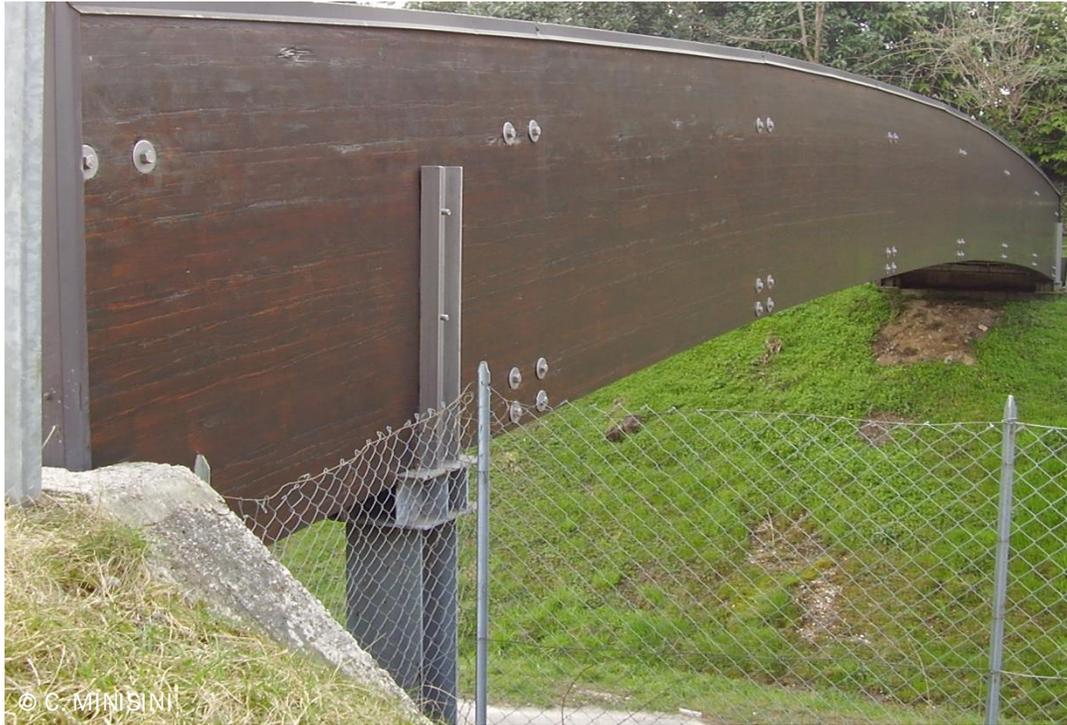
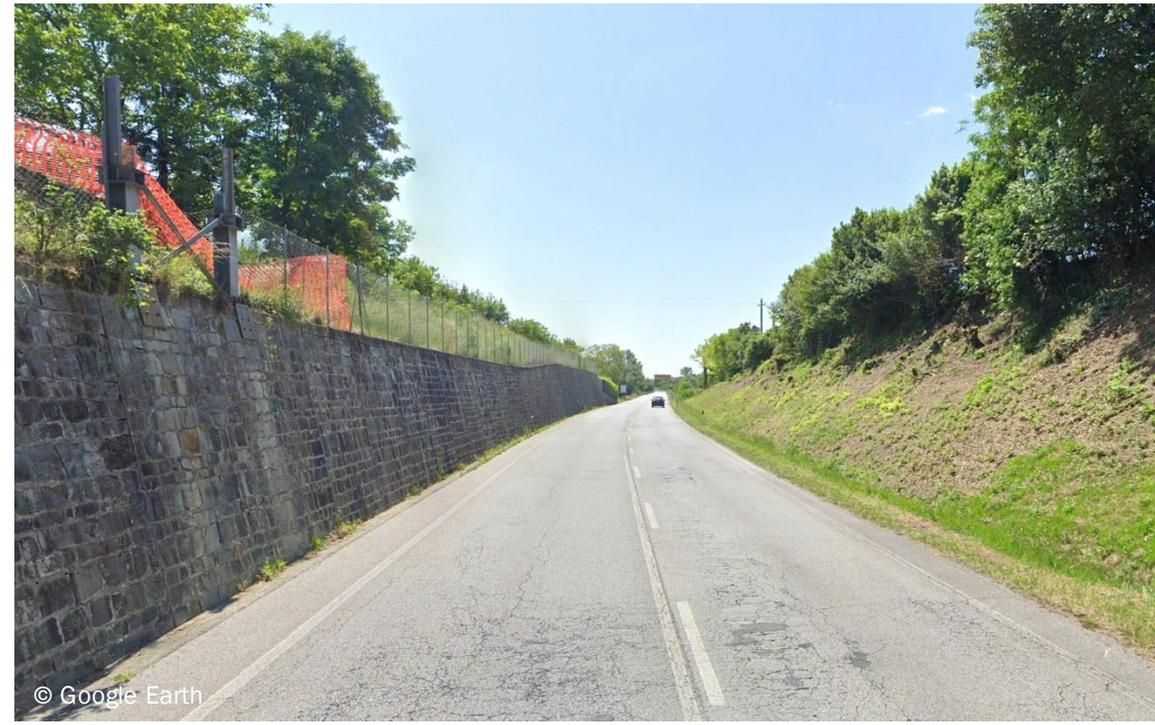
- ▷ Duration of less than 20 years
- ▷ Demolished without replacement

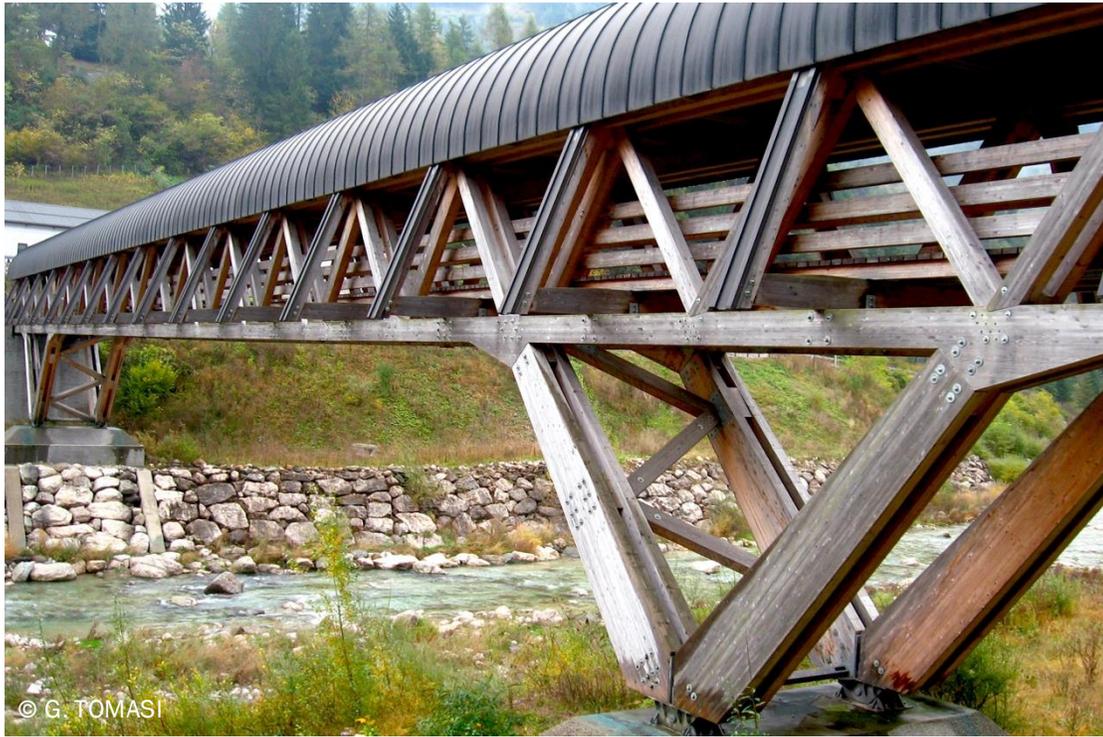
▷ Entirely timber-frame structure

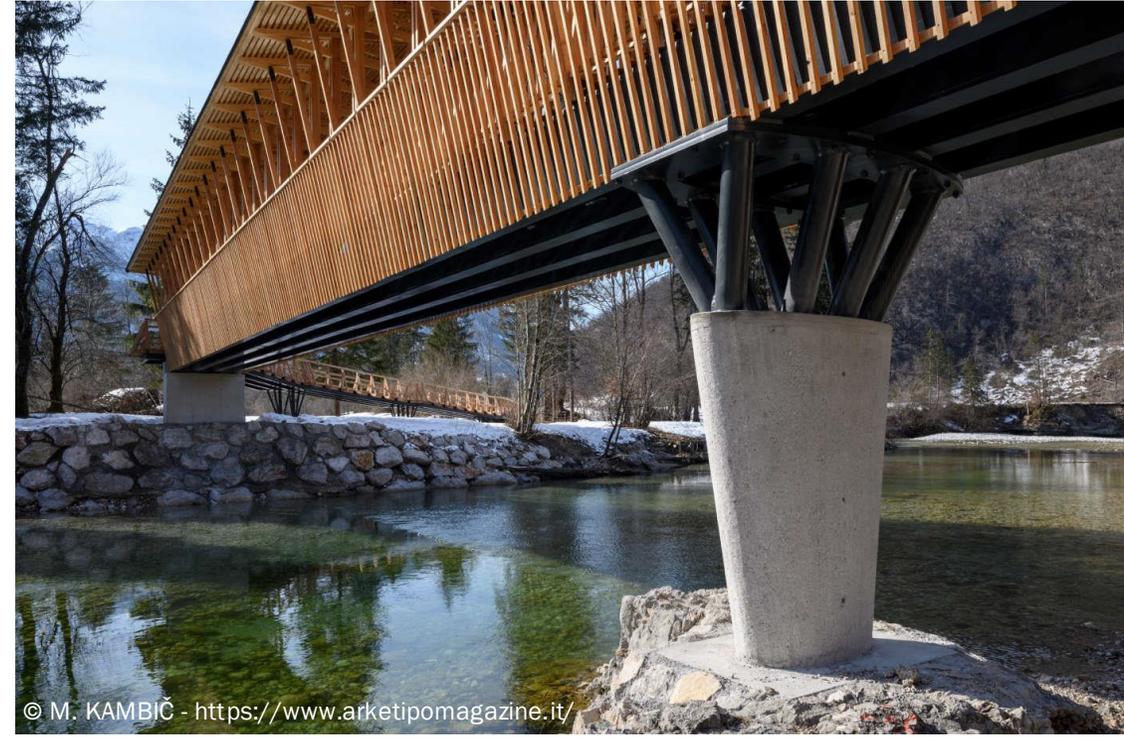
▷ Partially timber-frame/mixed structure

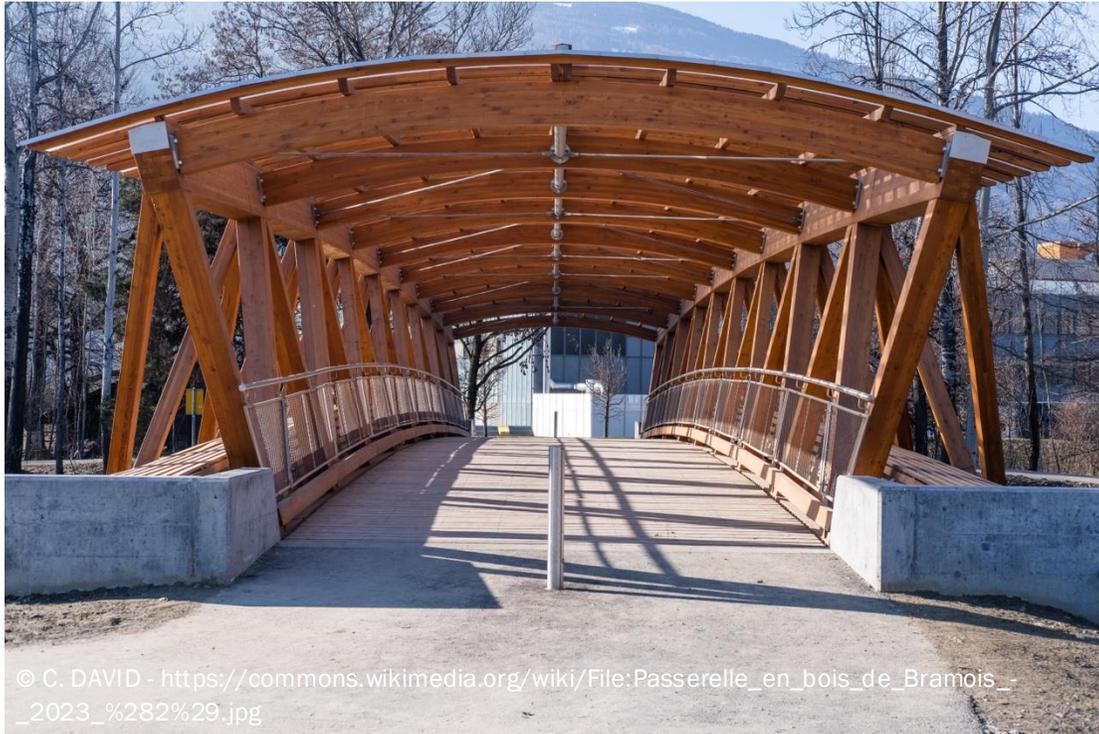
▷ Covered

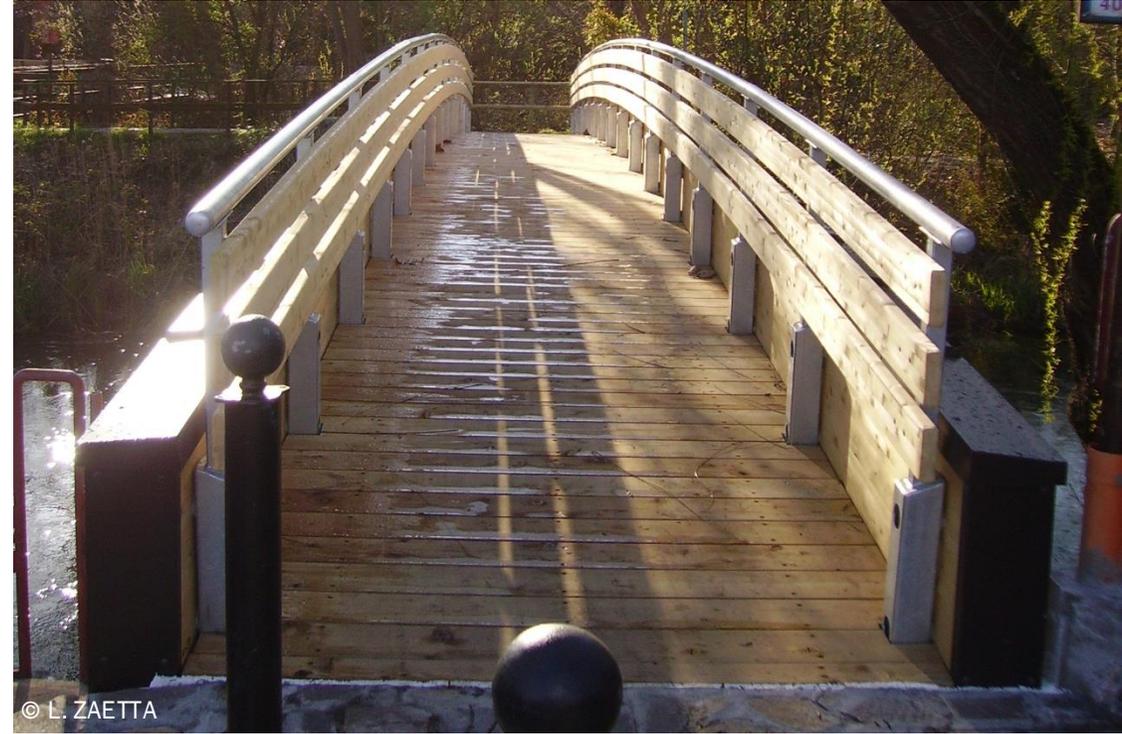
▷ Uncovered

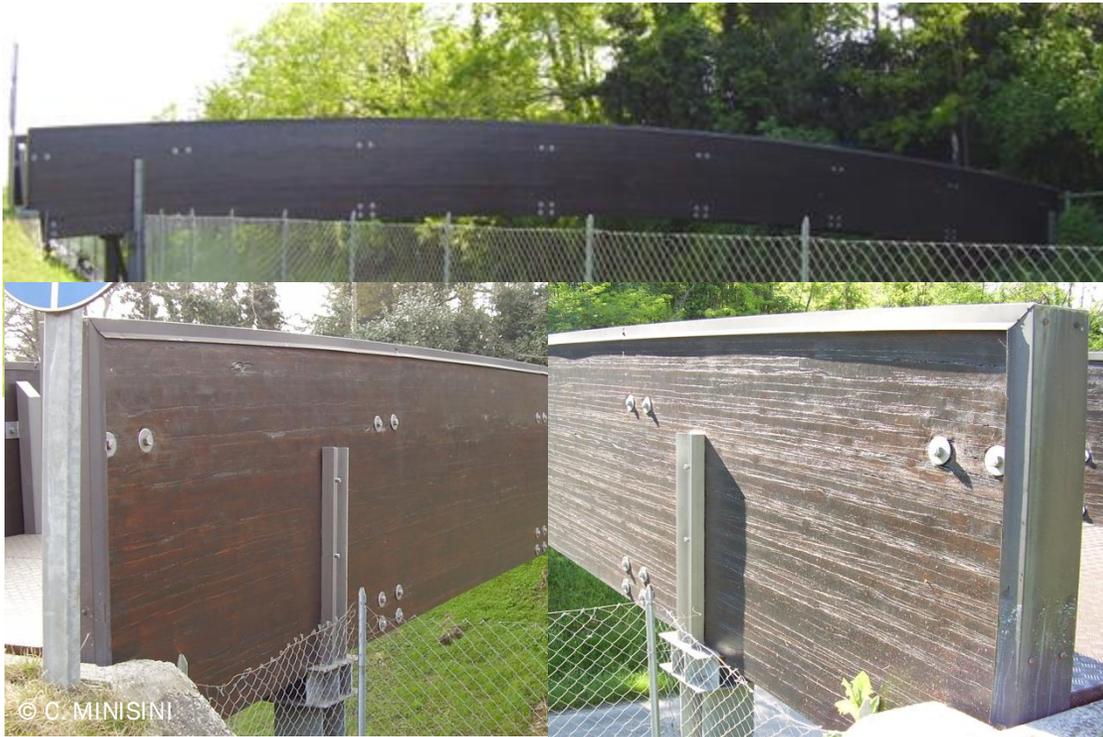
▷ Integrated parapet

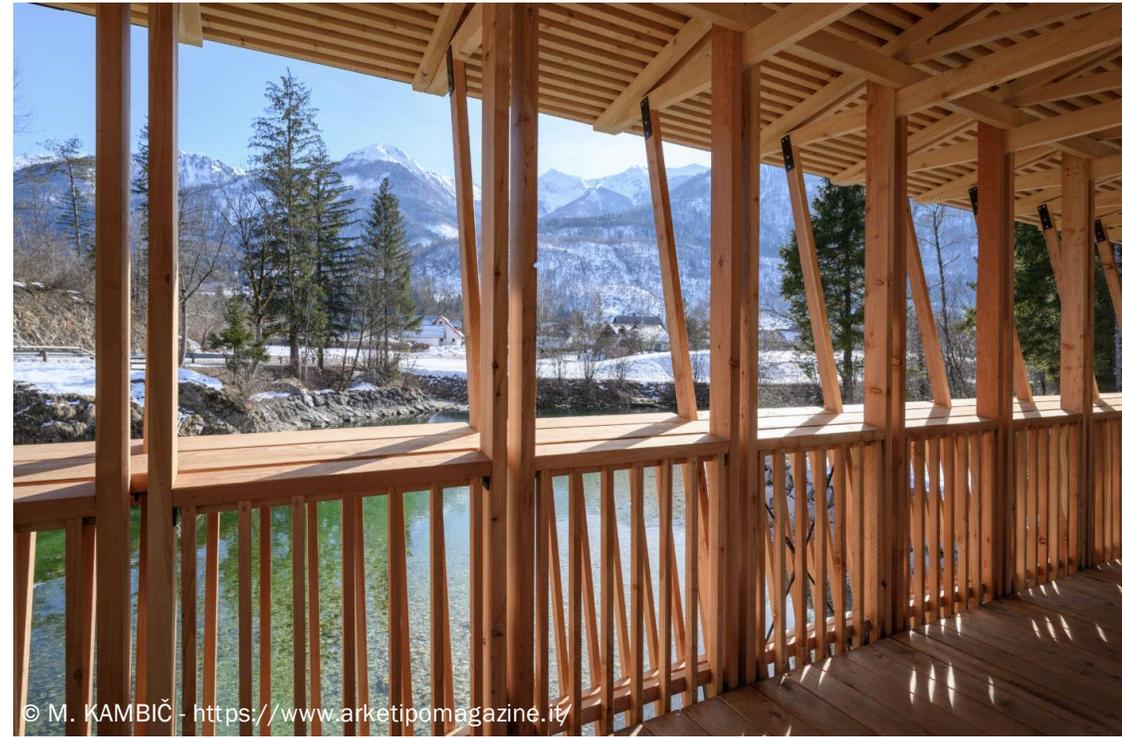
▷ Dedicated parapet

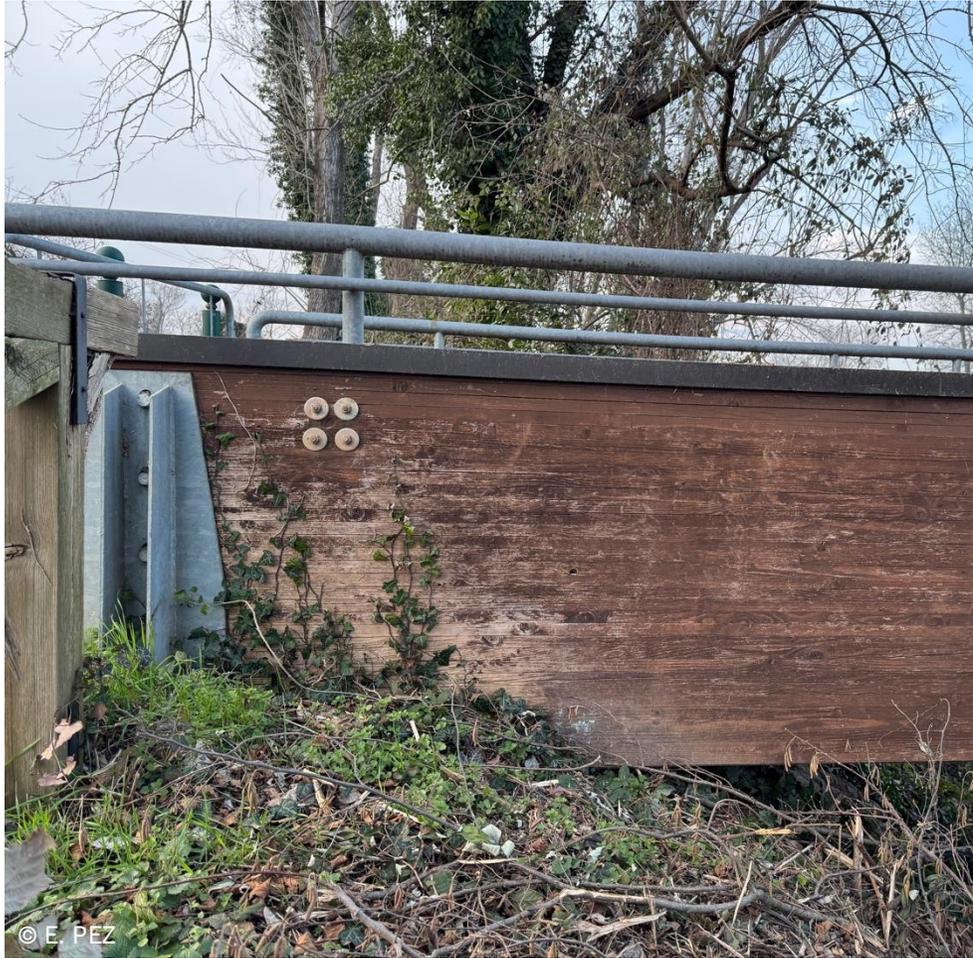
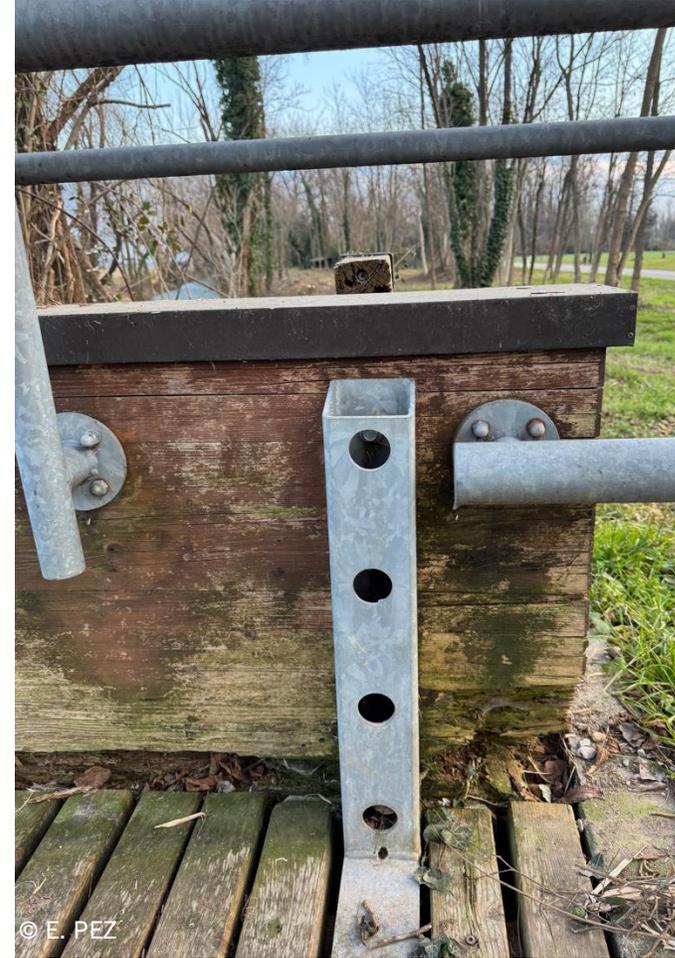
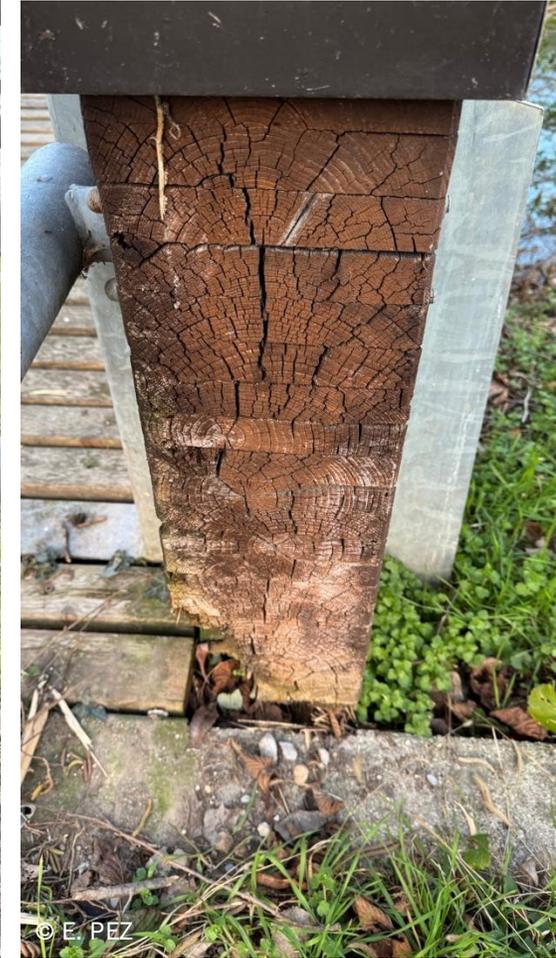
▷ Main beam – ground contact

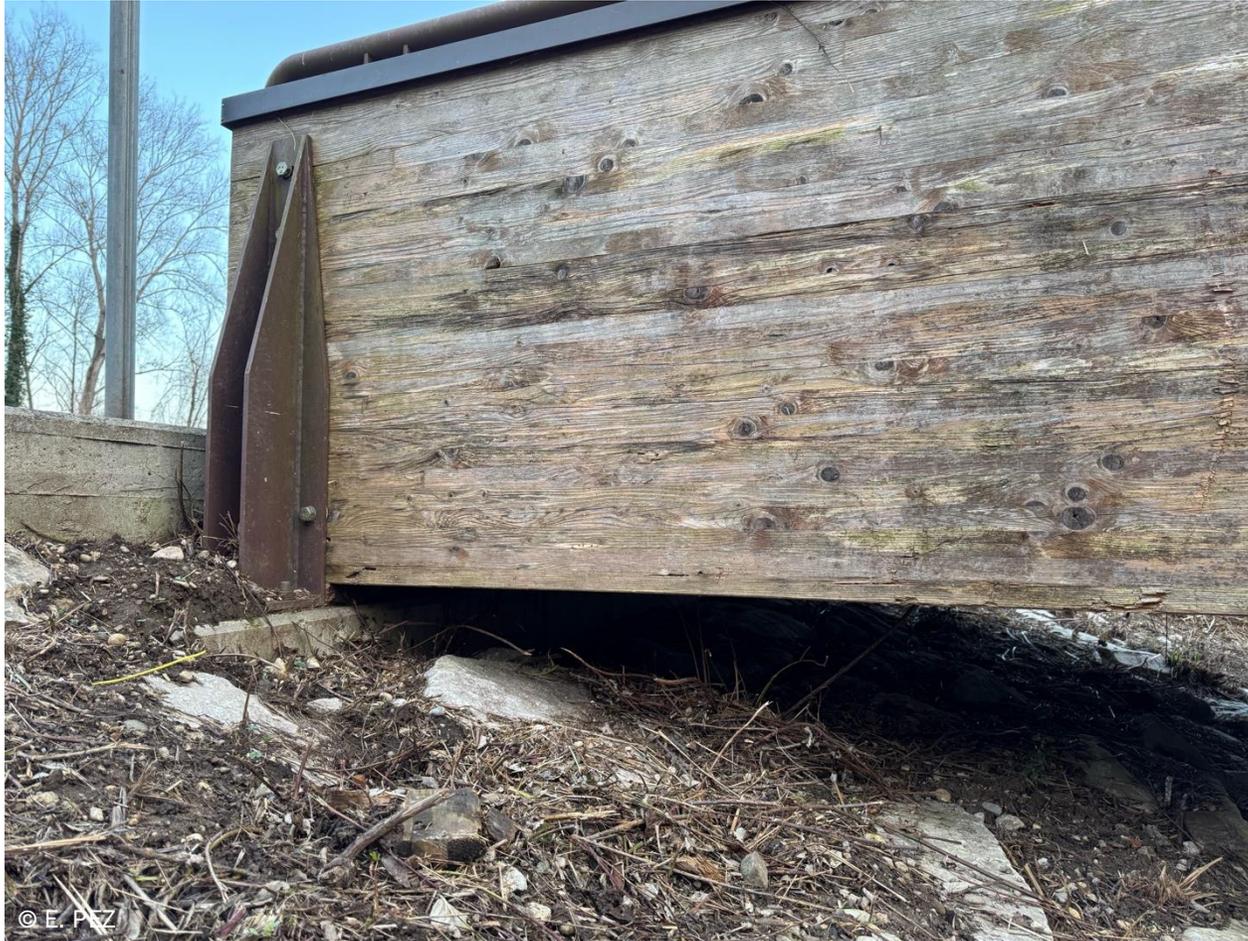
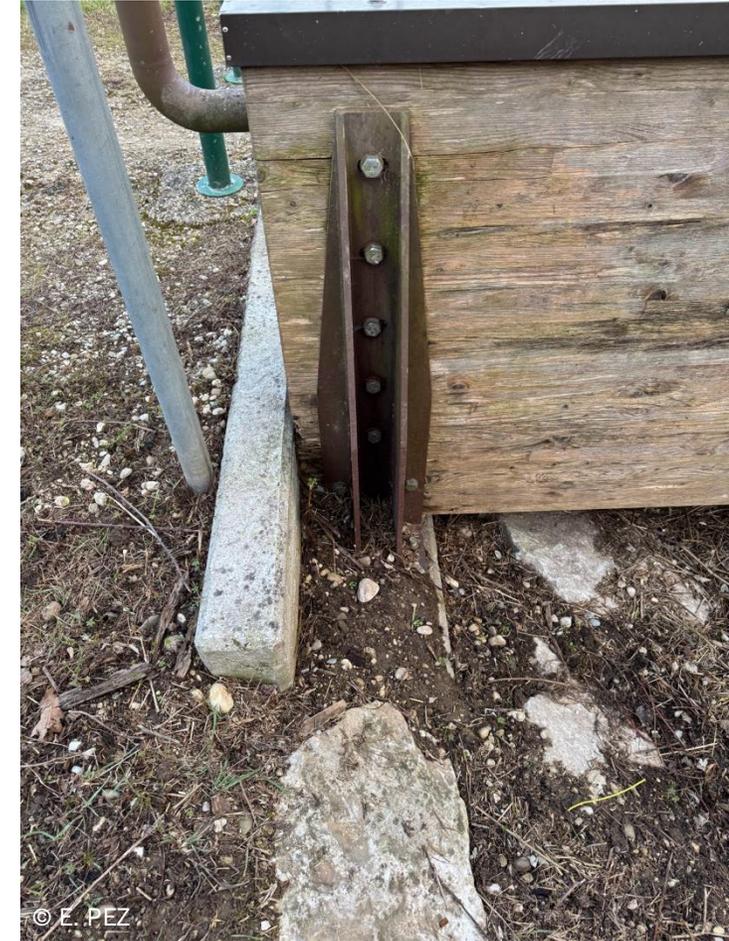
- ▷ Contatto travi principali - terreno

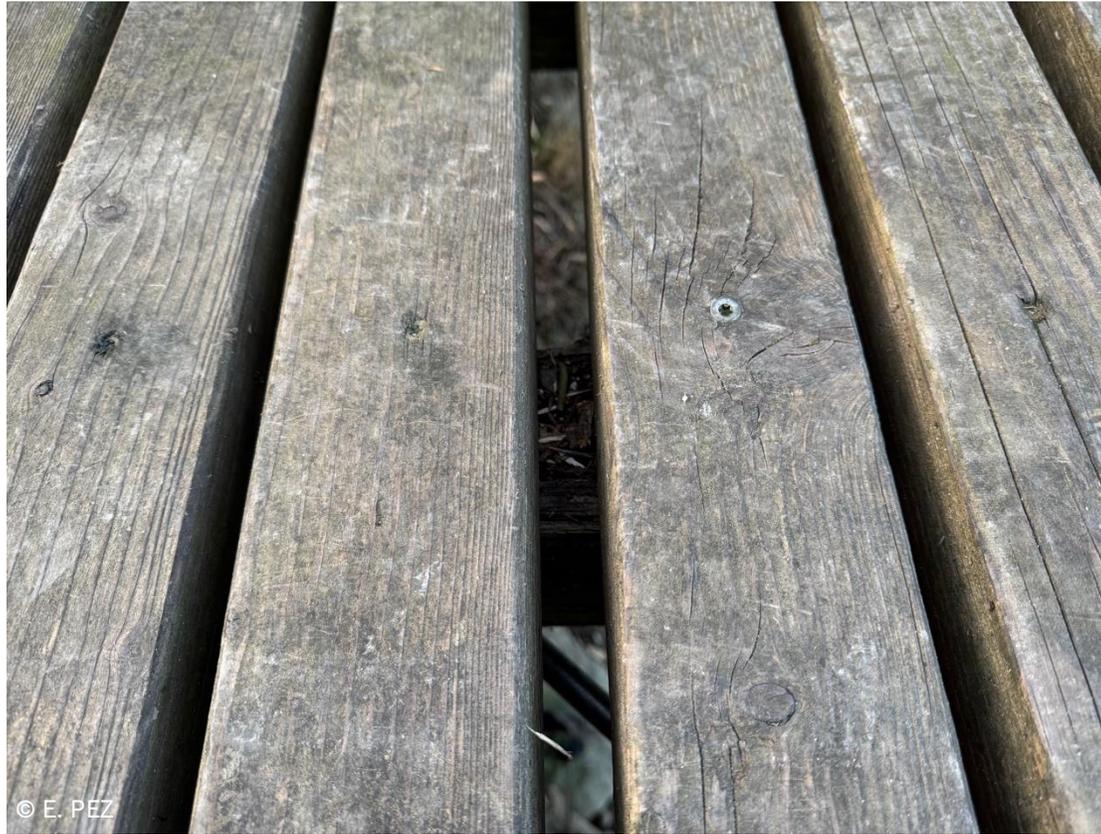
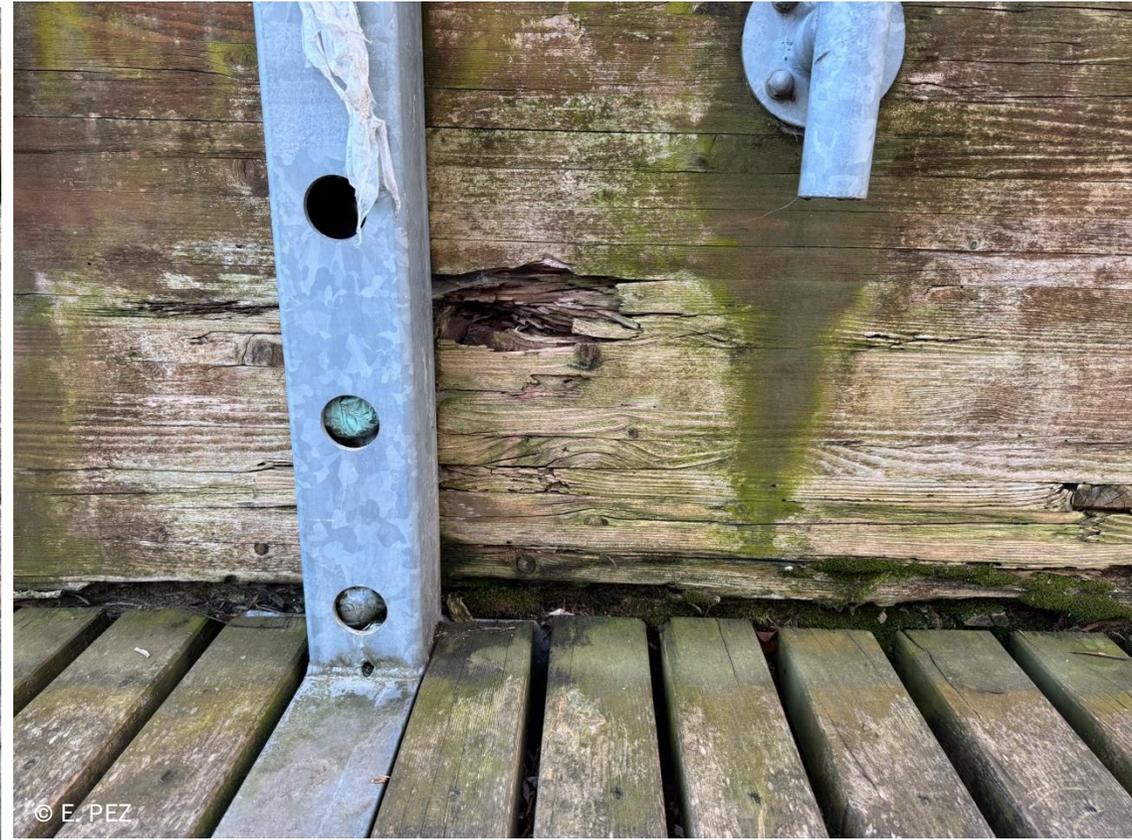
- ▷ Deck boards – beams contact
 - ▷ Debris accumulation near horizontal surfaces, spaces and boards heads

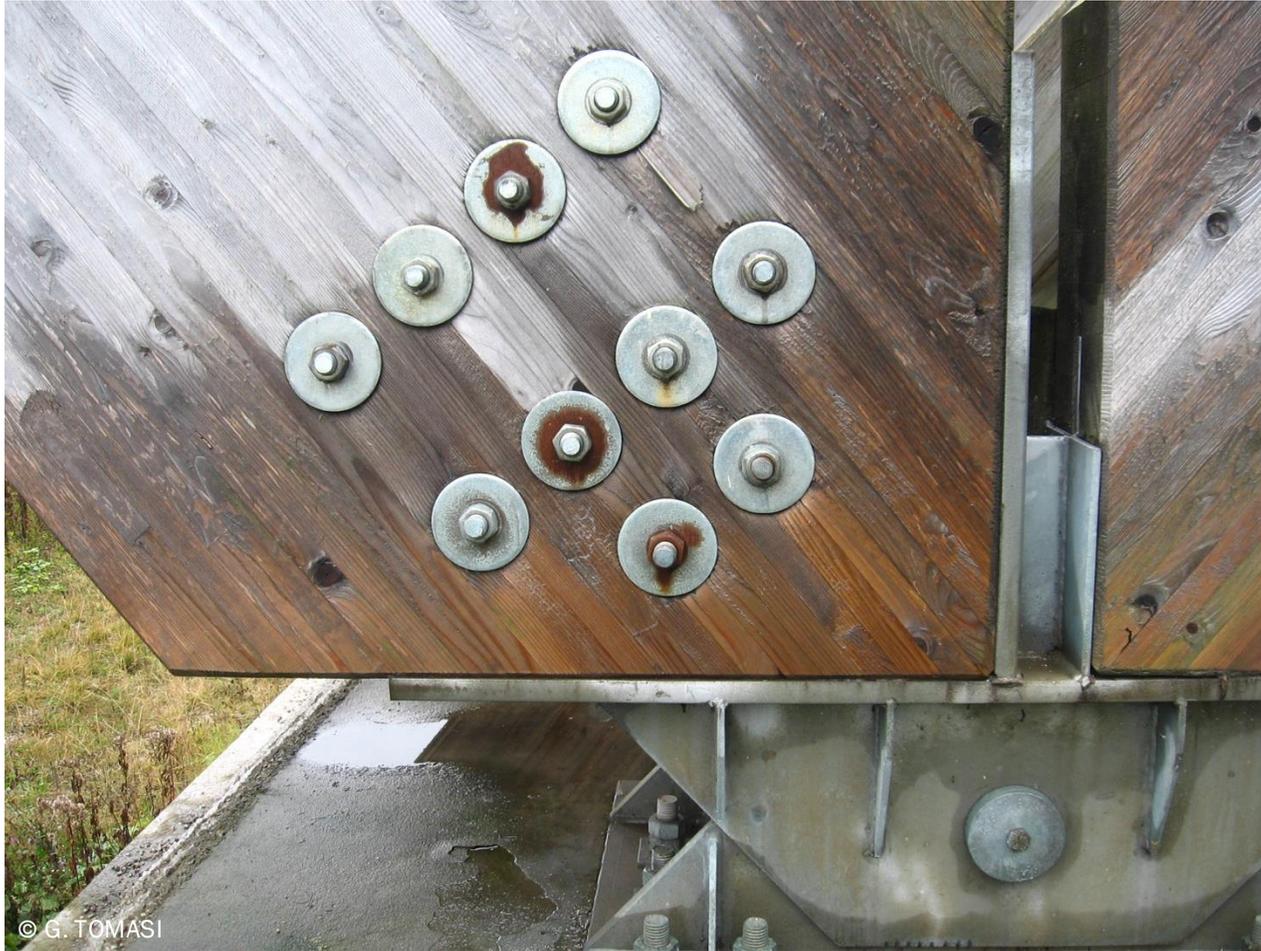
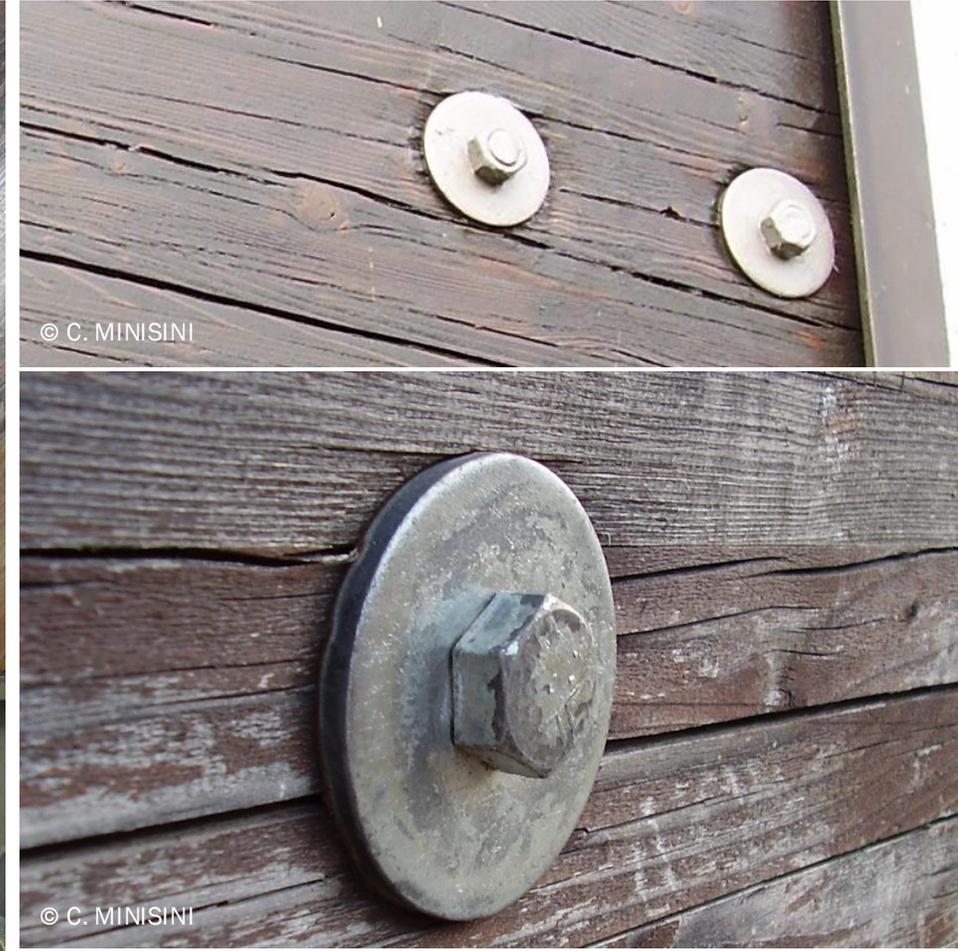
▷ Metal-wood connection contact

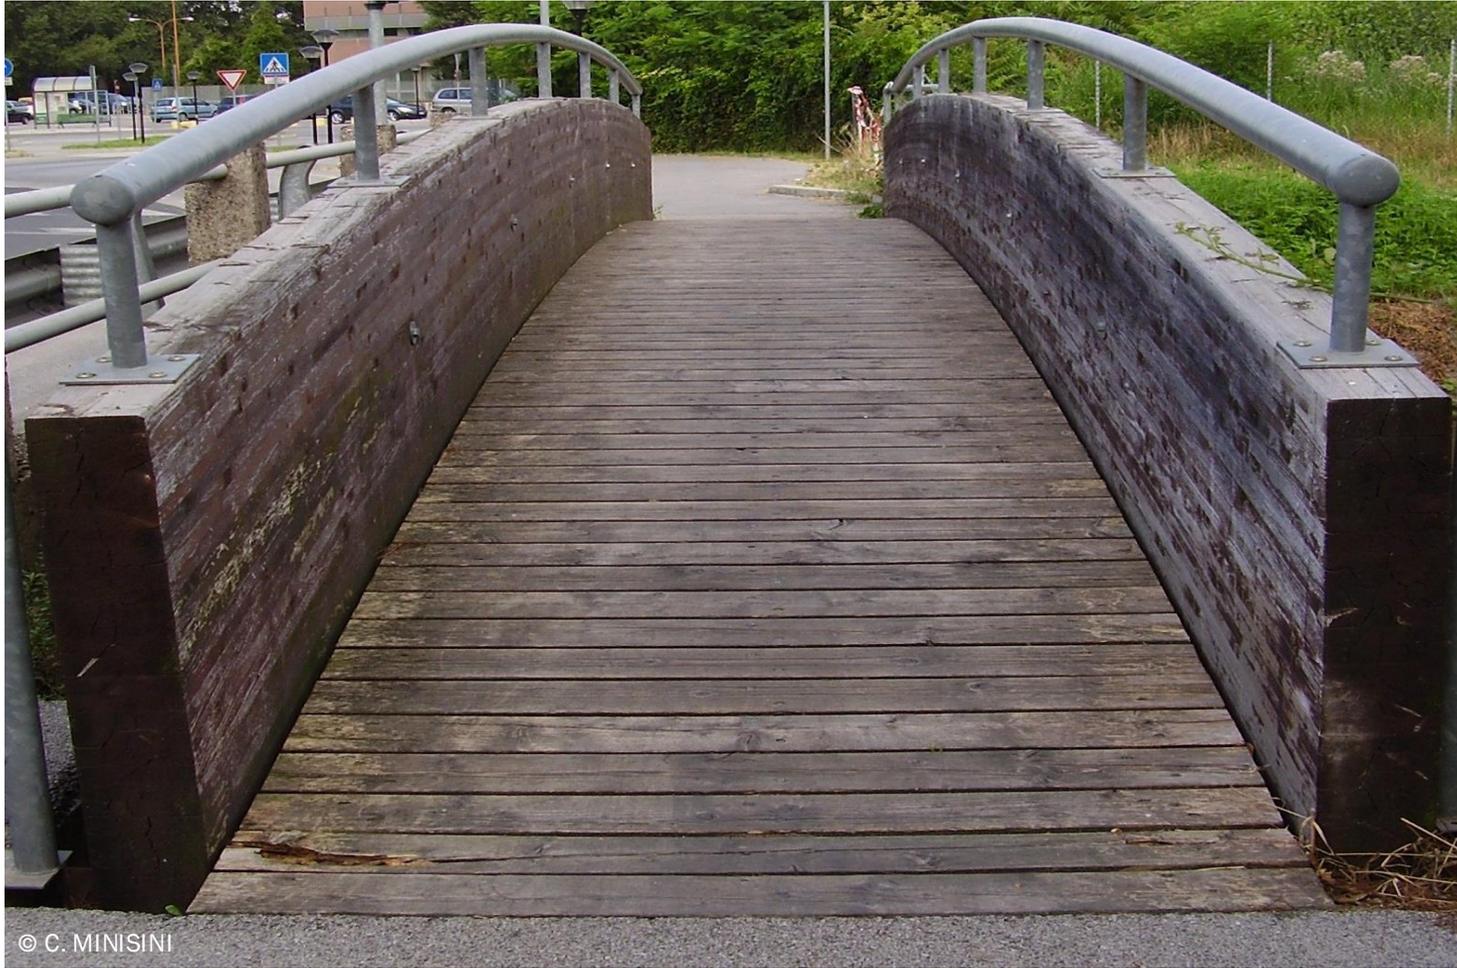
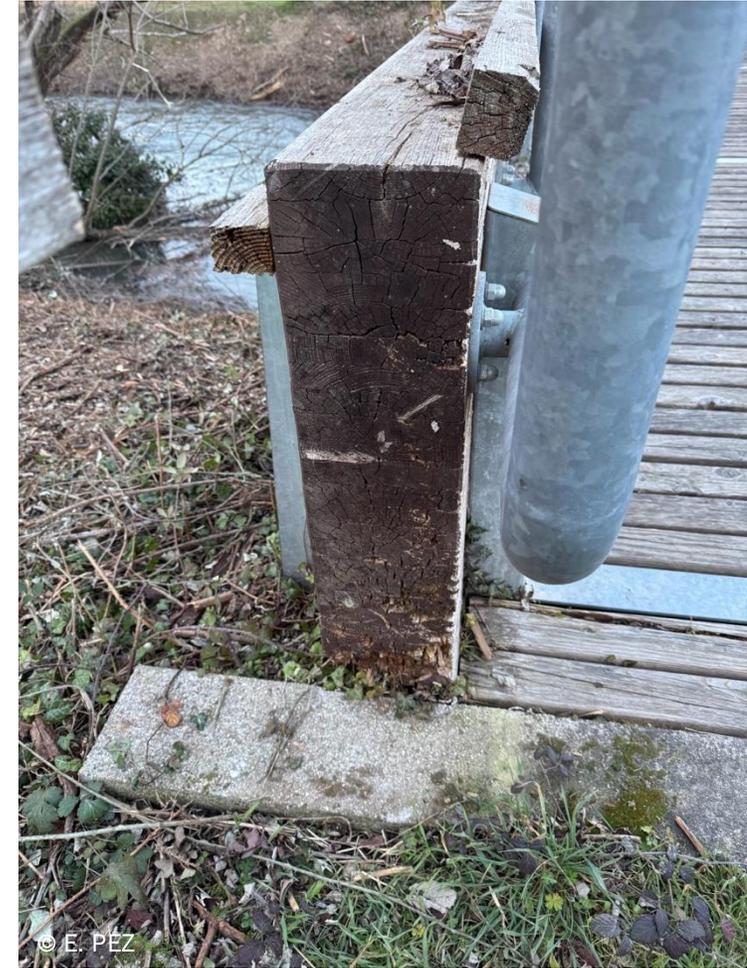
- ▷ Water accumulation on horizontal surfaces

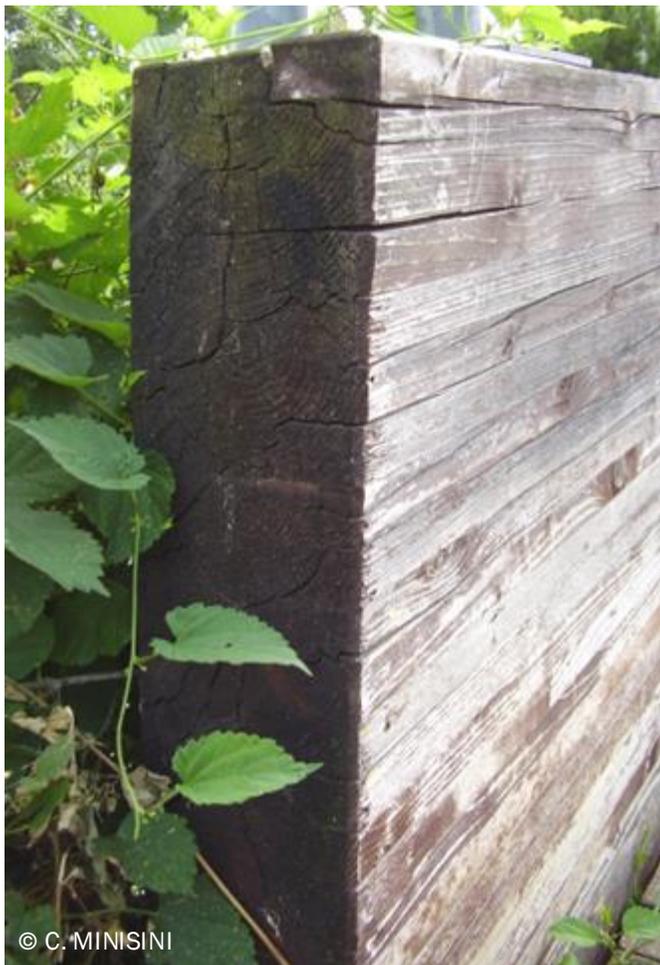
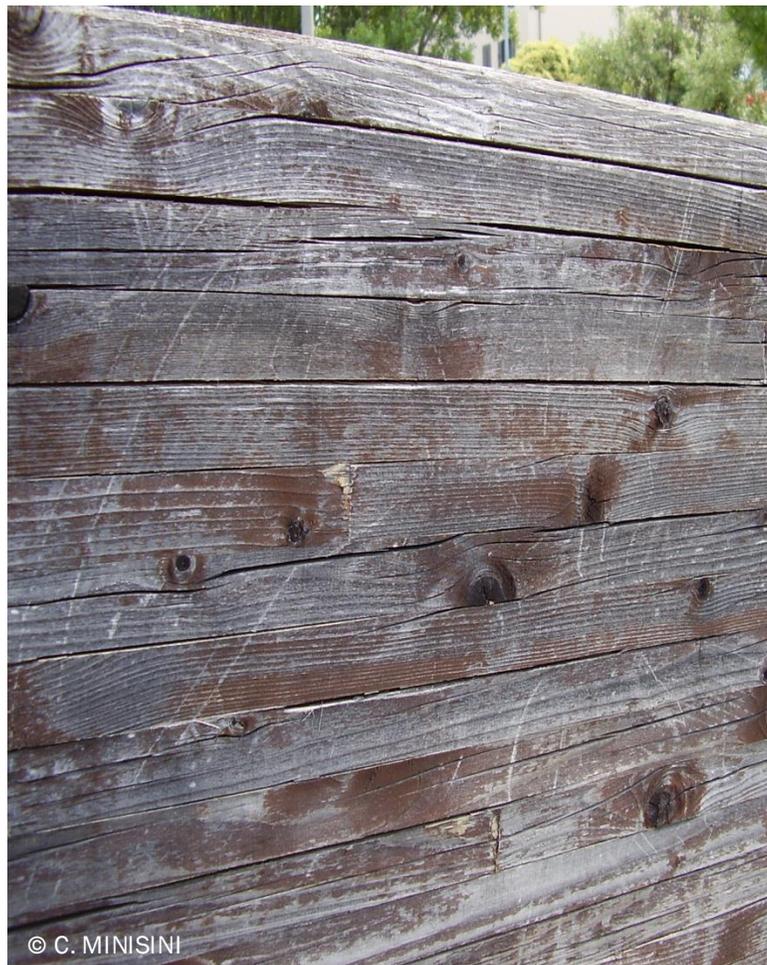
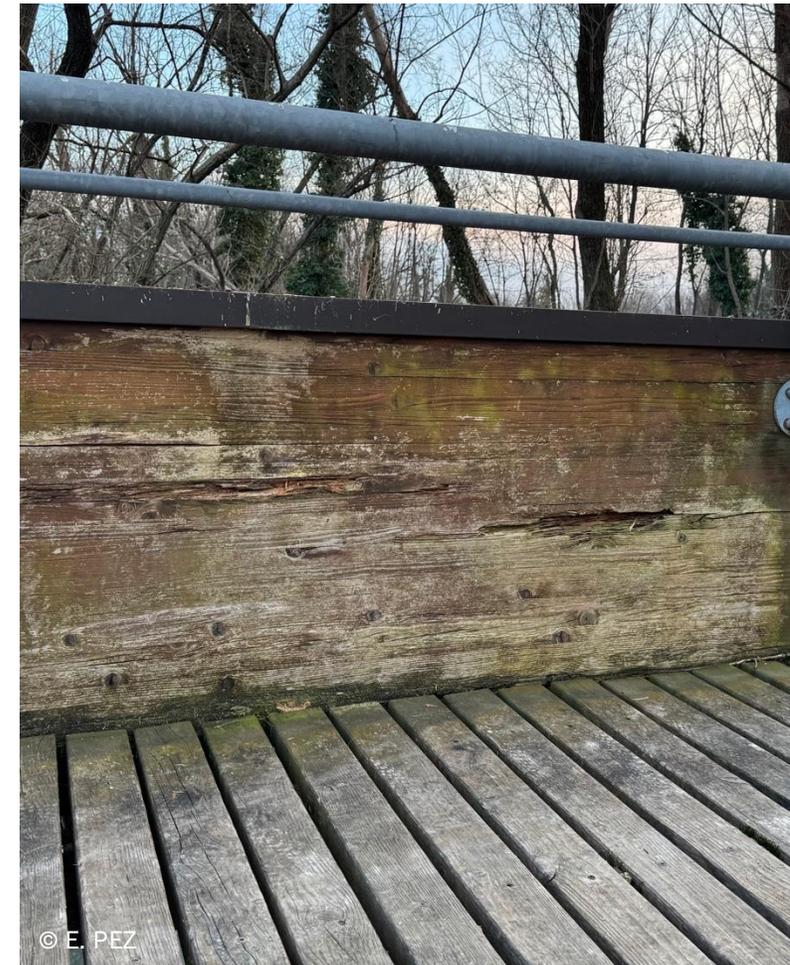
▷ Unprotected vertical surfaces

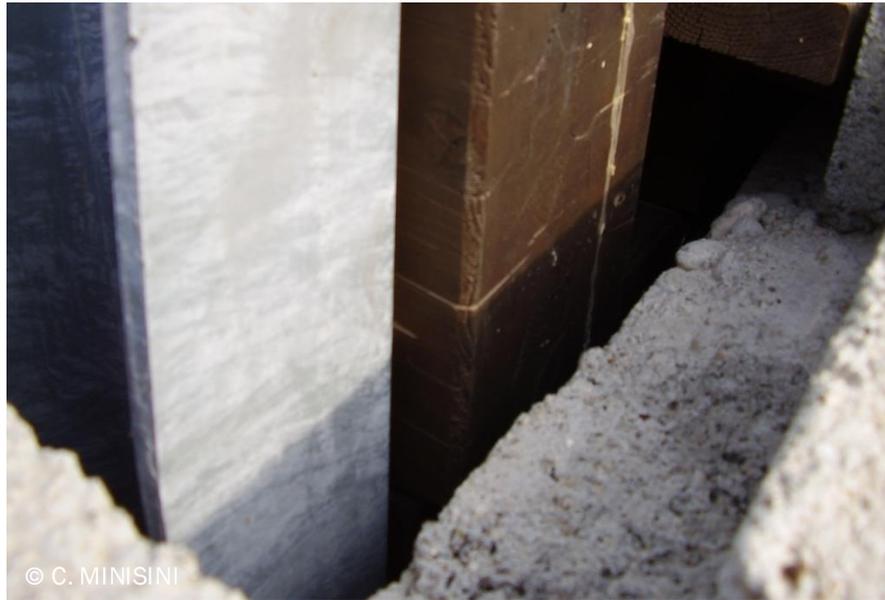
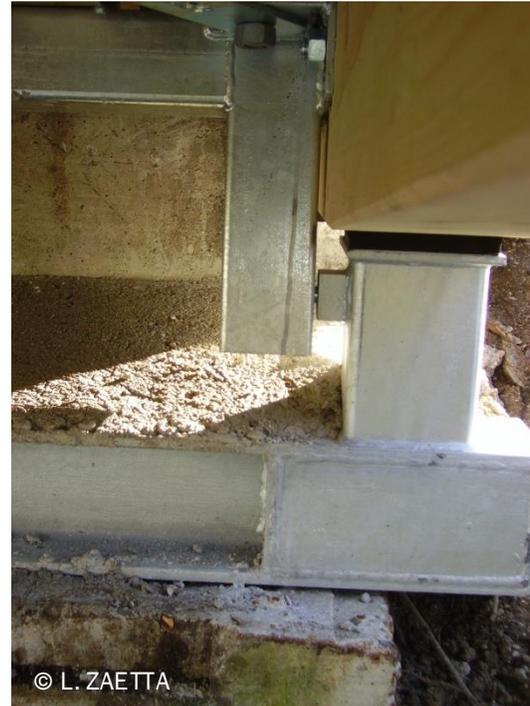
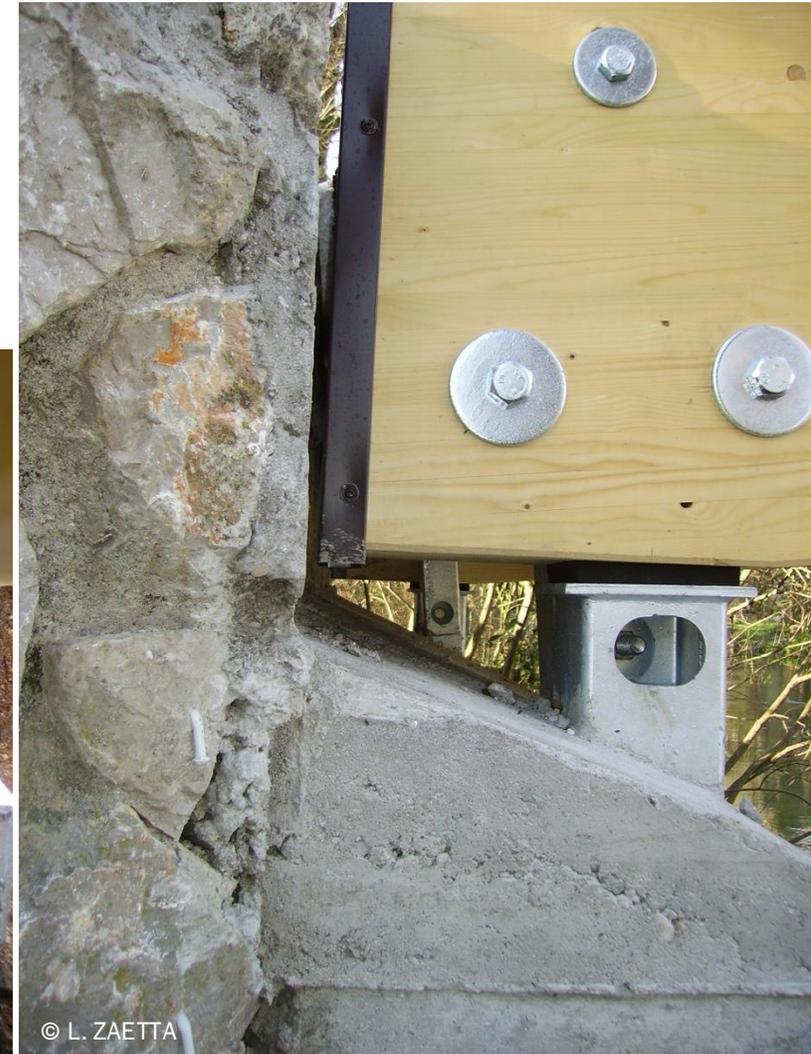
- ▷ Elevation of wooden parts
- ▷ Abutment modelling for water drainage
- ▷ Wood-metal and wood-concrete decoupling
- ▷ Beam head ventilation
