Durability of cycle-pedestrian
glulam footbridges.
From monitoring to Design for durability.

Enrico Pez

DURABILITY OF CYCLE-PEDESTRIAN GLULAM FOOTBRIDGES

FROM MONITORING TO DESIGN FOR DURABILITY

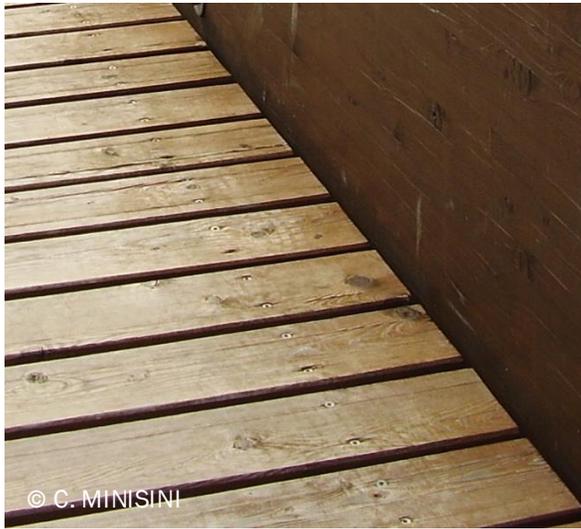
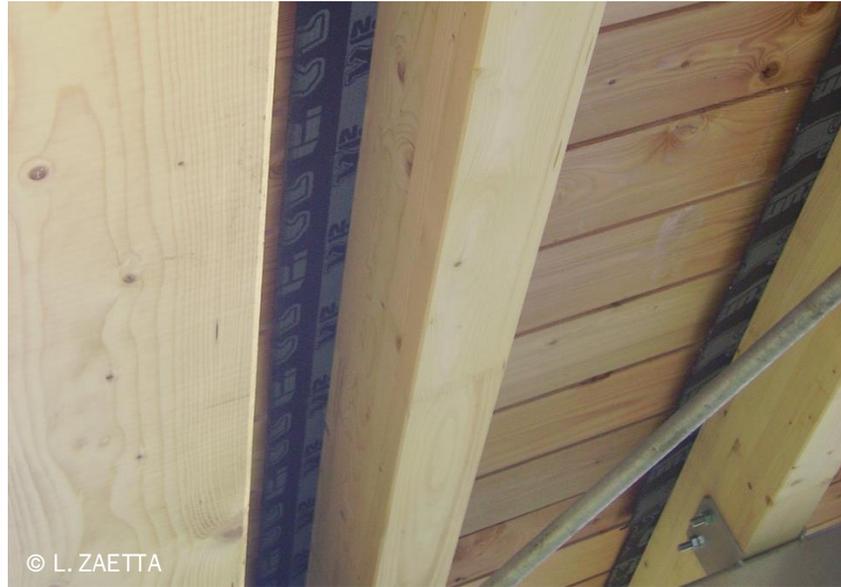
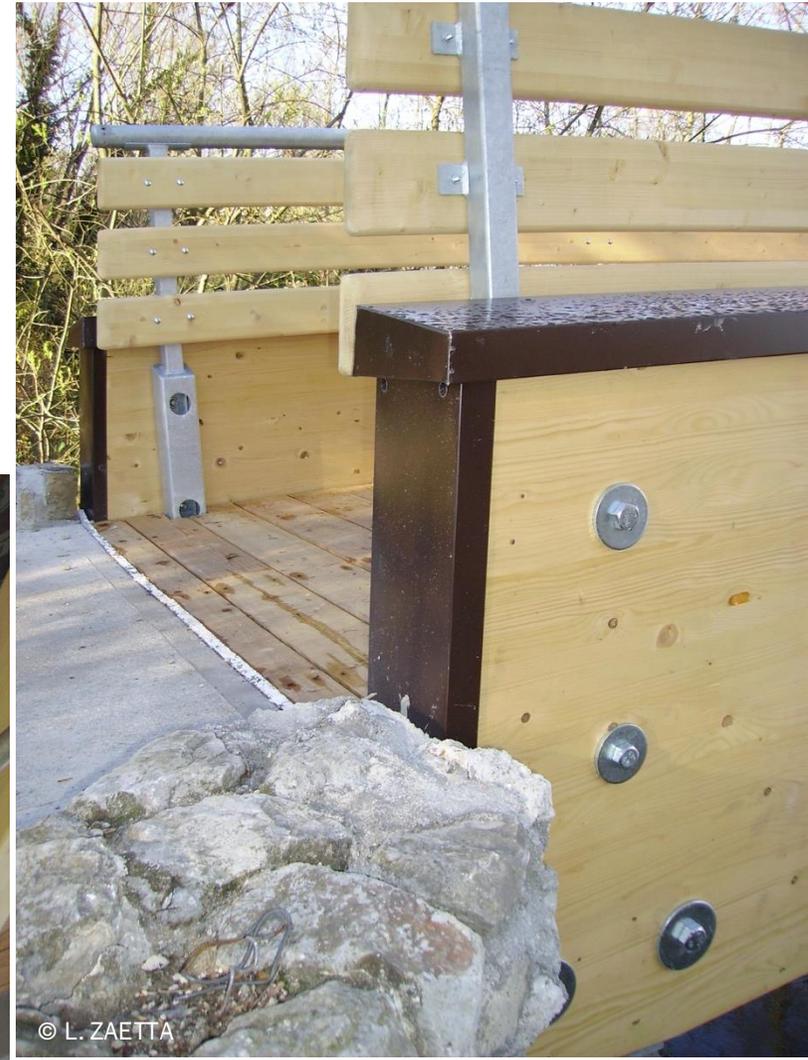
- ▷ Beam head cladding
- ▷ Waterproof coating of the contact surface between deckboards and joists
- ▷ Natural ventilation of deck boards ends

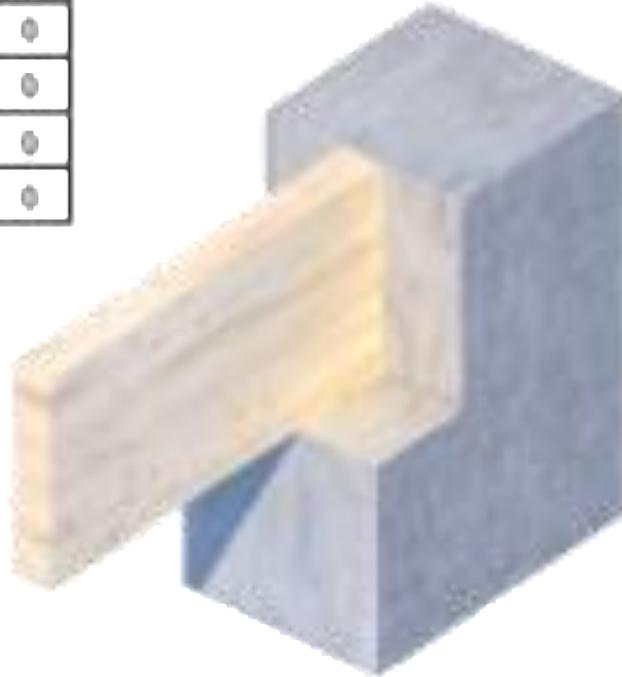
D1	0
D2	0
H	0
R	0
	0

Direct support and head contact of the beam

- D1 - direct runoff
- D2 - indirect runoff
- H - stagnation and infiltration moisture
- R - solar radiation

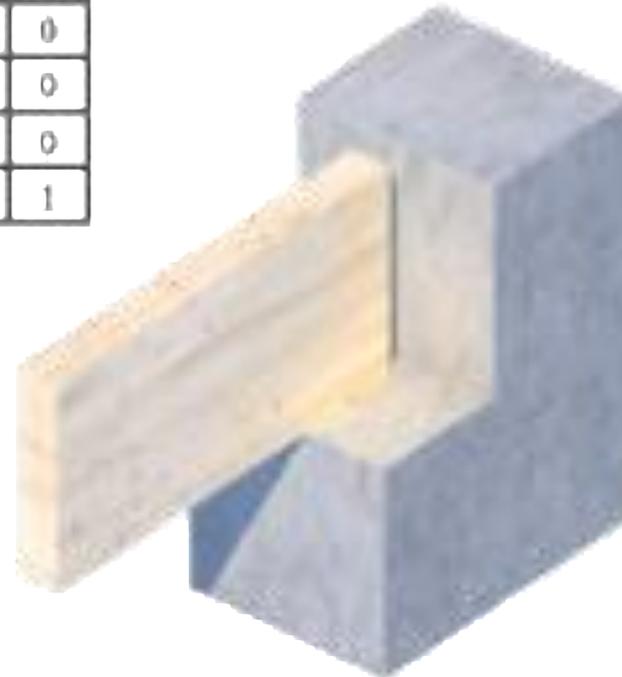
D1	1
D2	0
H	0
R	0
	1

Direct support and head contact of the beam

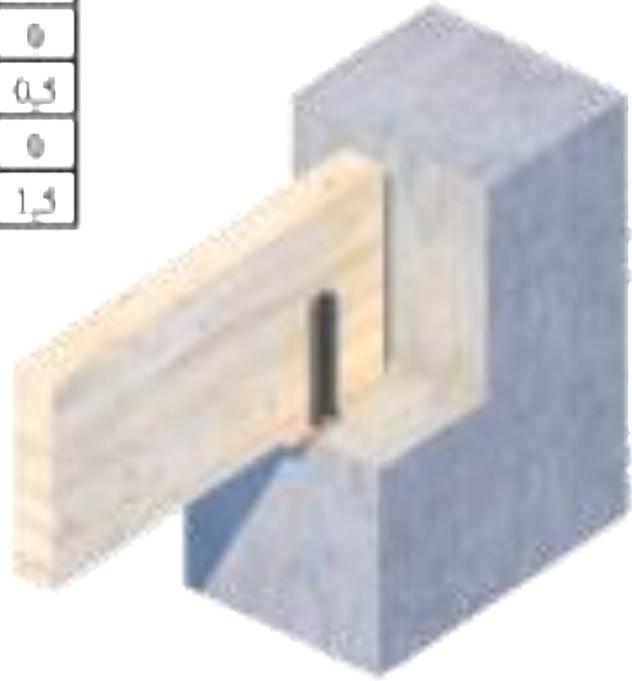
D1	1
D2	0
H	0,5
R	0
	1,5

Indirect support with minimum elevation

- D1 - direct runoff
- D2 - indirect runoff
- H - stagnation and infiltration moisture
- R - solar radiation

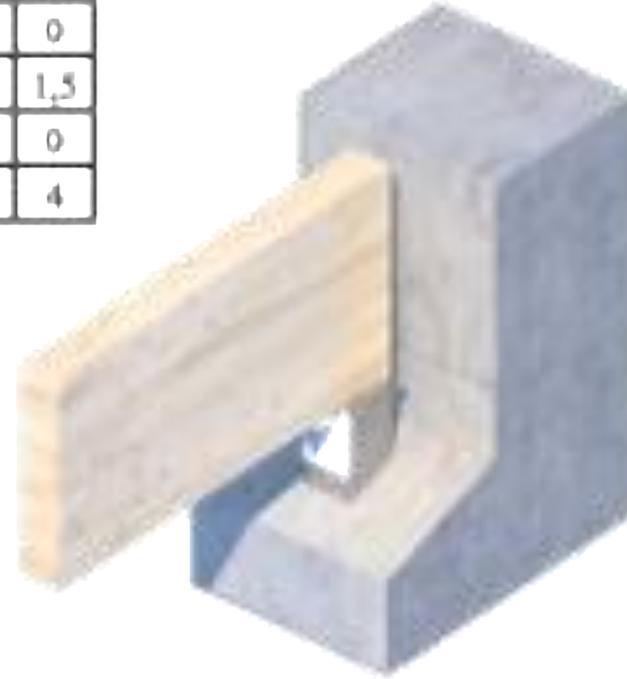
D1	2,5
D2	0
H	1,5
R	0
	4

Elevated support with inclined edge for water detachment

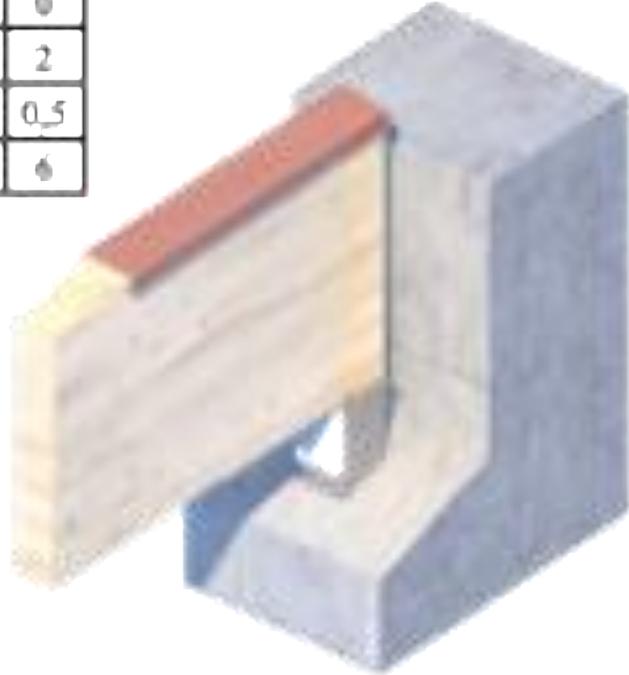
D1	3,5
D2	0
H	2
R	0,5
	6

Elevated support and top protective cover

- D1 - direct runoff
- D2 - indirect runoff
- H - stagnation and infiltration moisture
- R - solar radiation

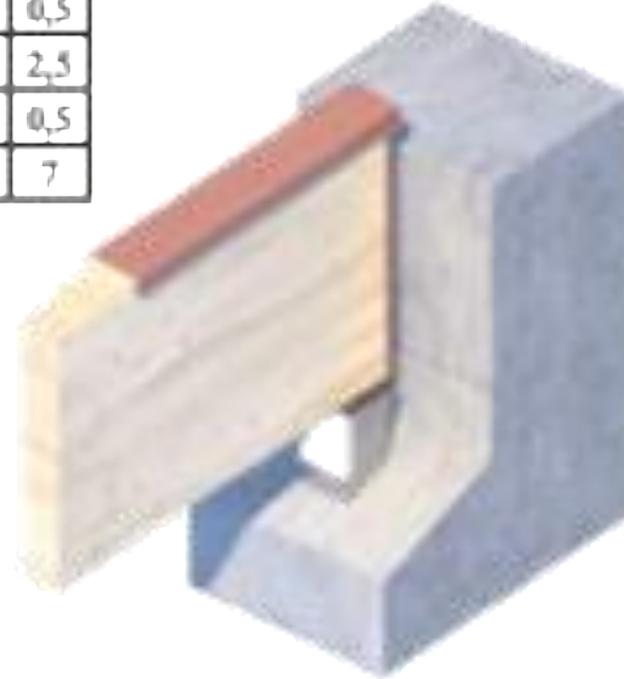
D1	3,5
D2	0,5
H	2,5
R	0,5
	7

elevated support with insulating element between wood and metal and top and top protective cover
